TECHNICAL REPORT NO. 226

AN EVALUATION OF THE RUST CONDITION OF
TRUCK, 1/4 TON: M151 SERIES

FEBRUARY 1978

ARMY MATERIEL SYSTEMS ANALYSIS ACTIVITY
ADELPHI PROVING GROUND, MARYLAND

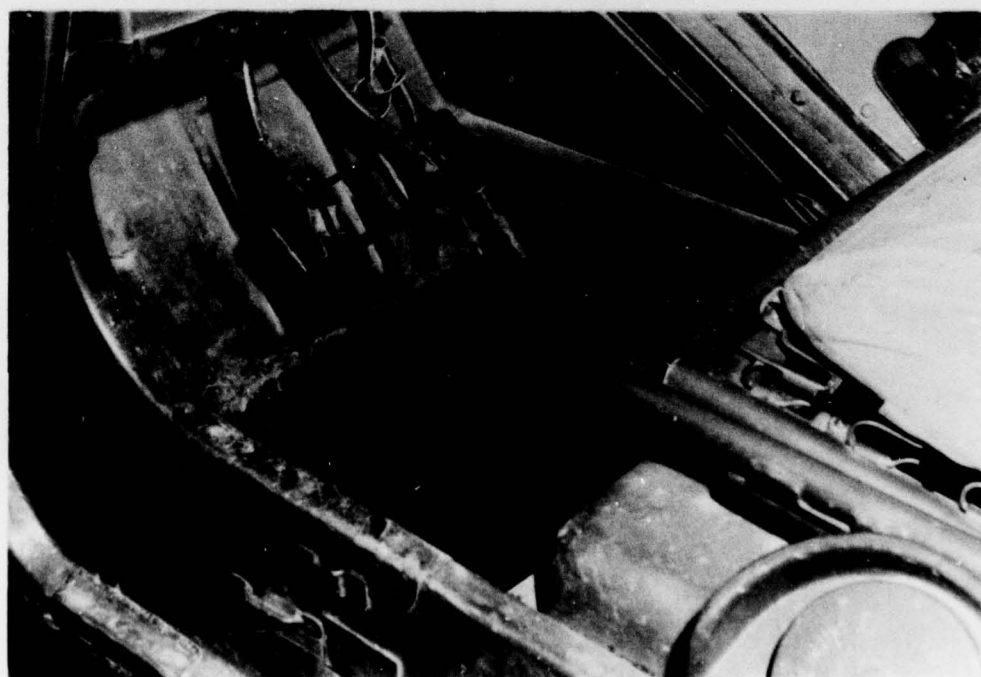
Photograph 1.1 - Front Floor Pans Showing Accumulation of Water.

(2) Drain holes should be enlarged and relocated so as to assure full drainage of water from the front floor area, regardless of the attitude of the vehicle when parked (See Photograph 1.1).

(3) Emphasis should be placed on periodic cleaning of all drain holes in the unit body, perhaps during a scheduled maintenance action.

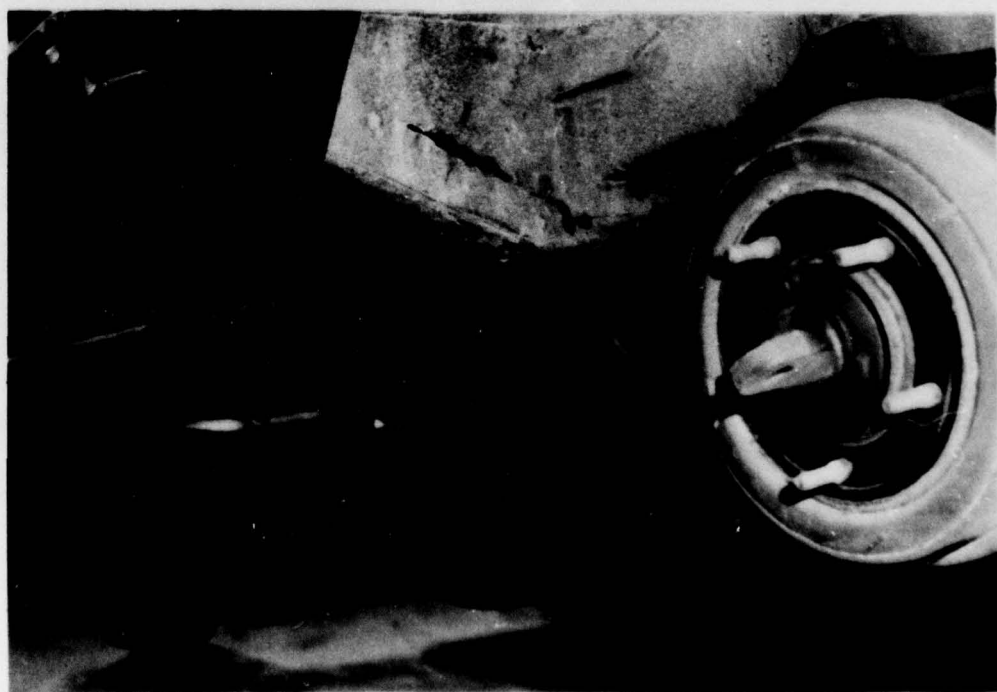
Photograph 4.5 -Typical Examples of Very Heavy Rust Condition.

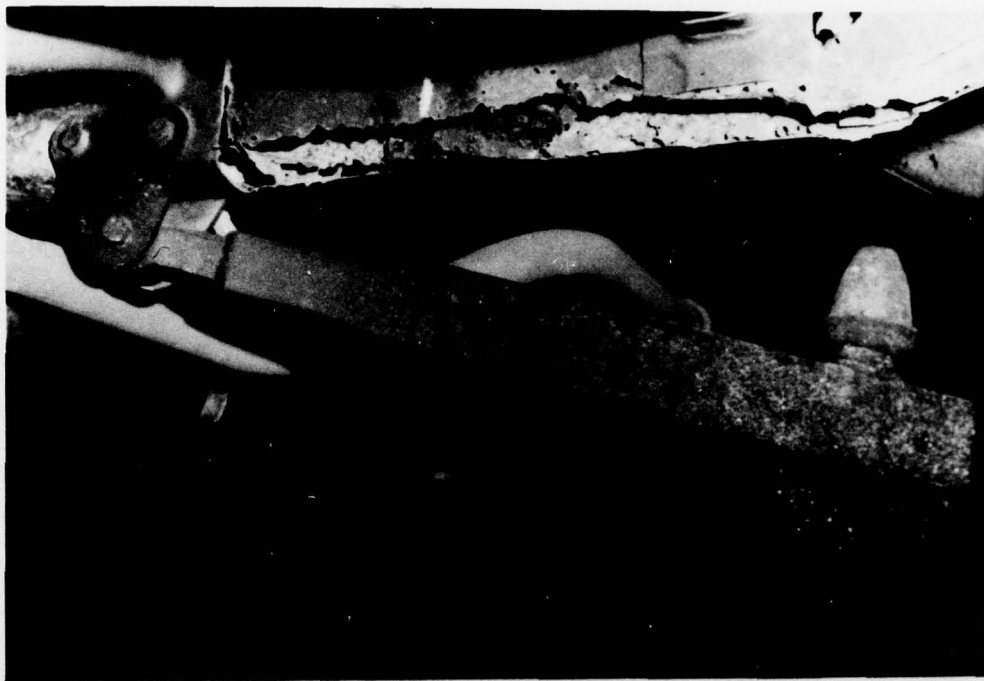
Photograph 6.1 - Typical Example of Severely Rusted Rear Cross Member.

Utilizing some of the procedures outlined in TM-9-2320-218-34 for repairing structural damage, Ft. Meade applied them to repairing severely rusted frame/cross members. In general, the method involved covering the rusted area with pre-formed or pre-shaped steel plates and electric welding them in place. Photographs 6.1 and 6.2 show a rear cross member and the left front, respectively, prior to being repaired. Photograph 6.3 shows pre-formed steel plates being welded over the left underside of the cross member. The method of capping the cross member, which is outlined in the above referenced TM, is shown in photograph 6.4. Photograph 6.5 shows a typical example of the left and right underside of a 1/4 ton truck after the front and rear cross members have been repaired, primed, and painted.

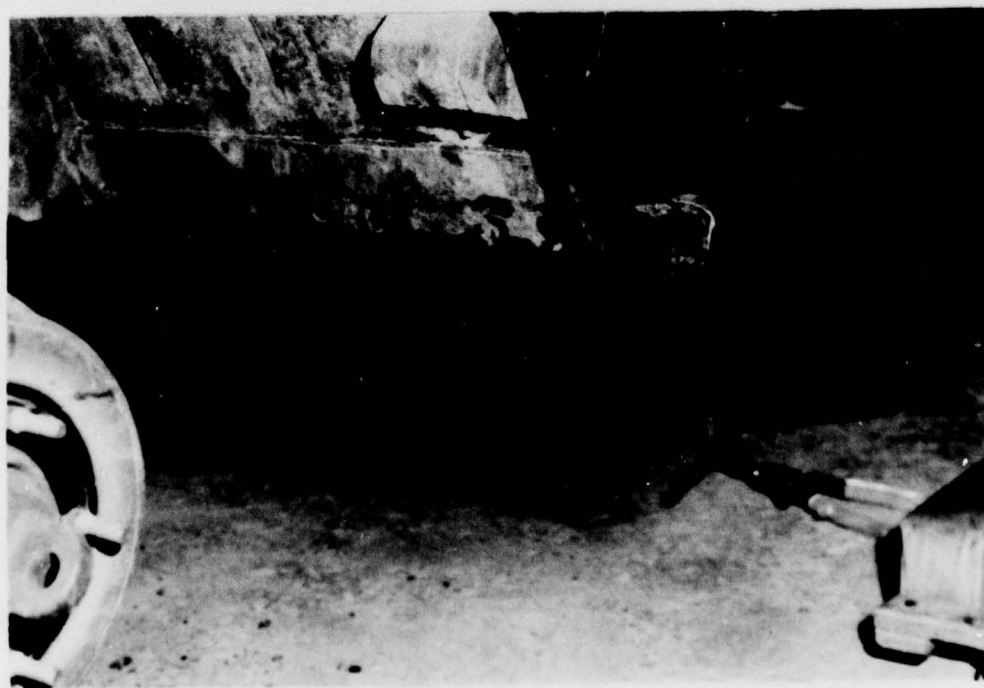
Photograph 6.2 - Typical Example of Severely Rusted Left-Front Cross Member.
